PHOTOGRAPHIC INTERPRETATION REPORT

SOUTHEAST ASIA ACTIVITY REPORT

SELECTED TRANSPORTATION AND INFILTRATION COMPENDIUM 1-7 SEPTEMBER 1966

NPIC/R-310/66 SEPTEMBER 1966

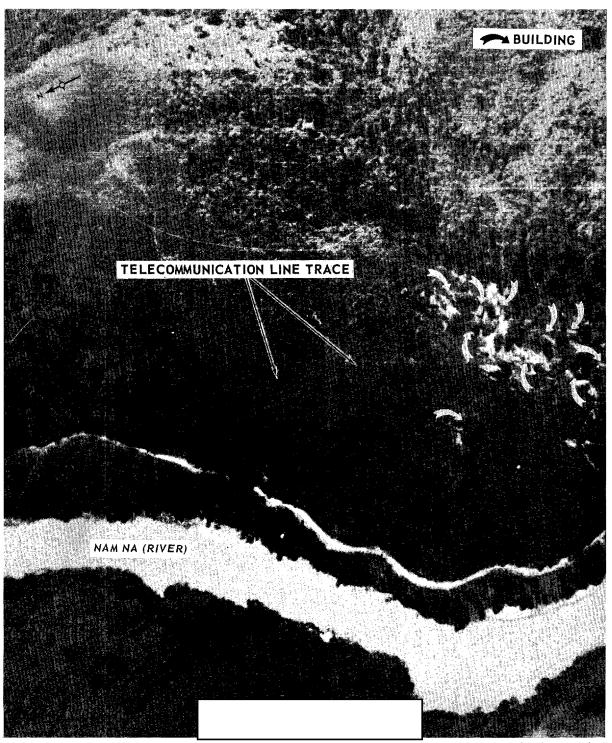
FIGURE 1. PROBABLE STORAGE AREA, ROUTE 6, NORTH VIETNAM

- Figure 1. A probable storage area containing at least 10 buildings is located east of Route 6 at 22-20N 103-10E (UTM UK122718).
- Figure 2. A probable storage area containing 24 buildings is located at 22-17N 103-10E (UTM UK112647). A service road extends east from Route 6 and follows a small stream into the area.
- Figure 3. Two probable storage areas containing a total of 13 buildings are located at 22-14N 103-10E (UTM UK114604) and are each connected to Route 6 by a short service road.
 - Figure 4. A probable storage area containing at least four buildings is

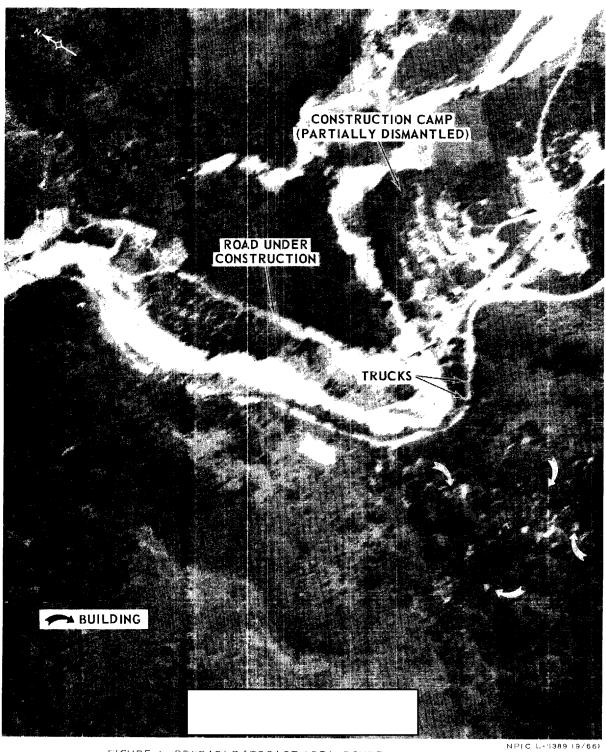
FIGURE 4. PROBABLE STORAGE AREA, ROUTE 6, NORTH VIETNAM

located immediately southeast of Route 6 at 22-11N 103-10E (UTM UK115573). Road construction continues on the opposite bank of the Nam Cay (river) and a partially dismantled construction camp is located nearby.

The road network between Lai Chau and China is generally complete and serviceable, although bridges are under construction at minor stream crossings which now utilize fords and temporary bridges (Figures 4 and 24). A ferry crossing over the Nam Na (river) is located on Route 6 immediately north of its junction with Route 604 (Figure 25). A five-span highway bridge has been constructed 1 nm southwest of Phong Tho on Route 132 (Figure 26), indicating that Route 604 has apparently been developed as the major link with China, via Phong Tho and Route 132.

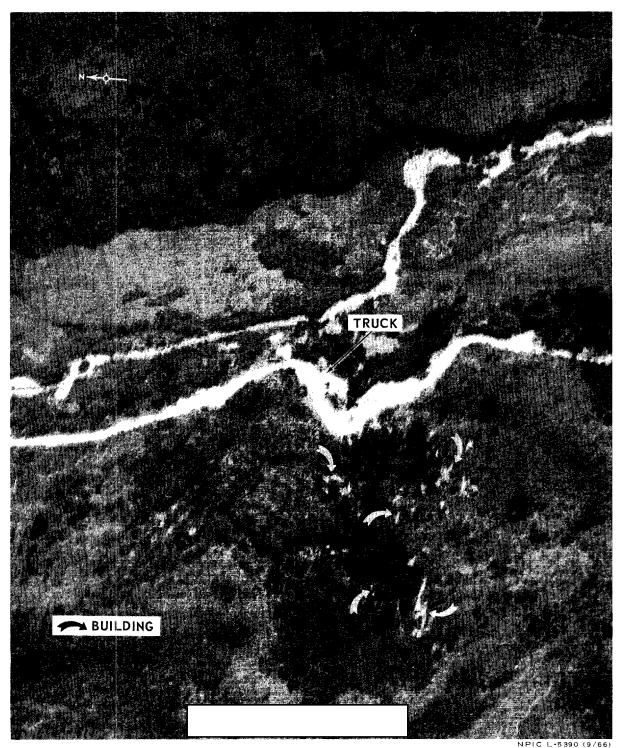
FIGURE 5. PROBABLE STORAGE AREA, ROUTE 6, NORTH VIETNAM

- Figure 5. A probable storage area containing at least five buildings is located adjacent to Route 6 at 22-11N 103-10E (UTM UK119569).
- Figure 6. A probable storage area containing at least four buildings is located northeast of Route 6 at 22-11N 103-10E (UTM UK117564). A possible storage cave is immediately south and heavy vehicular tracking is observed in the area.

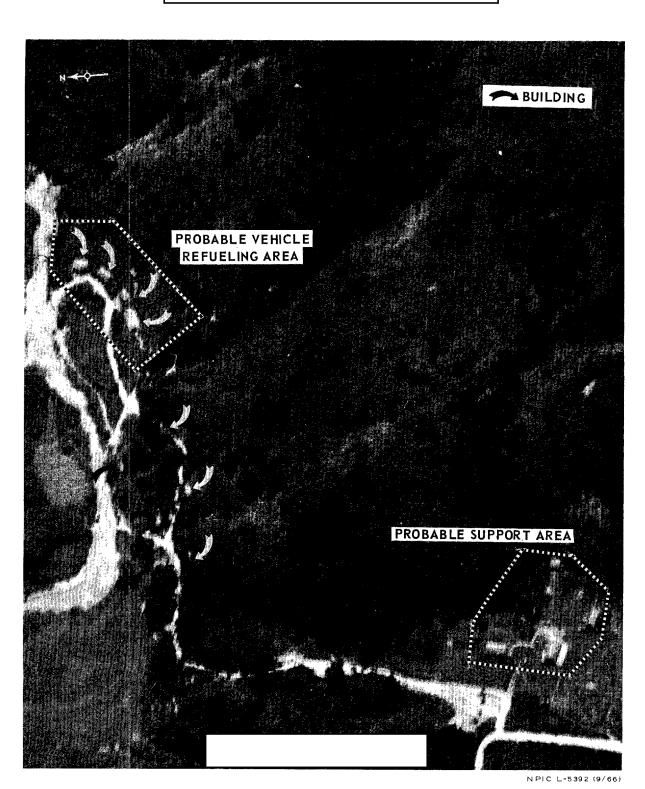
FIGURE 7. PROBABLE VEHICLE REFUELING FACILITY, ROUTE 6, NORTH VIETNAM

- Figure 7. A probable vehicle refueling facility containing four buildings at the head of a loop road is located east of Route 6 at 22-11N 103-10E (UTM UK125566). A service road extends from Route 6 to the facility and a probable support area immediately east of this junction contains six buildings.

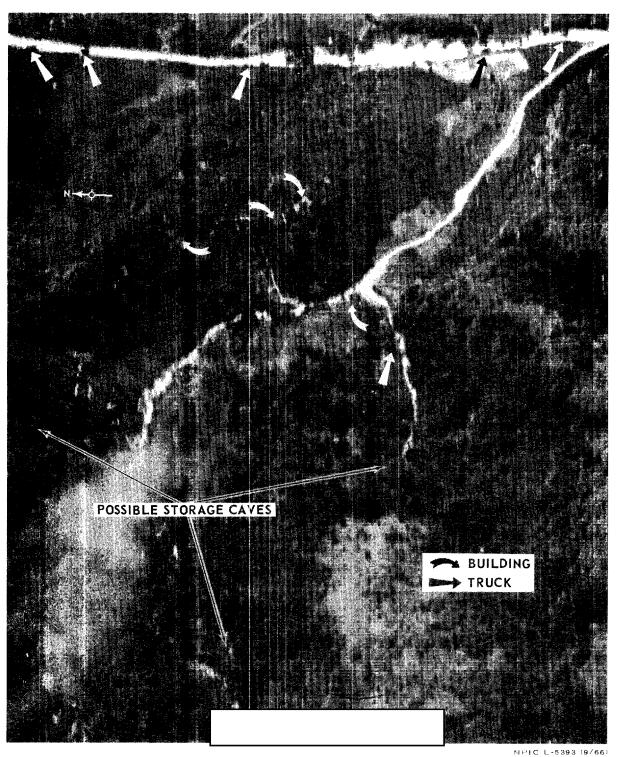
FIGURE 8. PROBABLE STORAGE AREA, ROUTE 6, NORTH VIETNAM

- Figure 8. A probable storage area is located at 22-llN 103-10E (UTM UK117558). A heavily used service road extends northeast from Route 6 to a possible storage cave. Two spur roads extend to two additional possible storage caves and a third spur road extends to a probable support area containing at least four buildings. Five trucks are on Route 6 adjacent to the storage area and one truck is parked on a spur road.

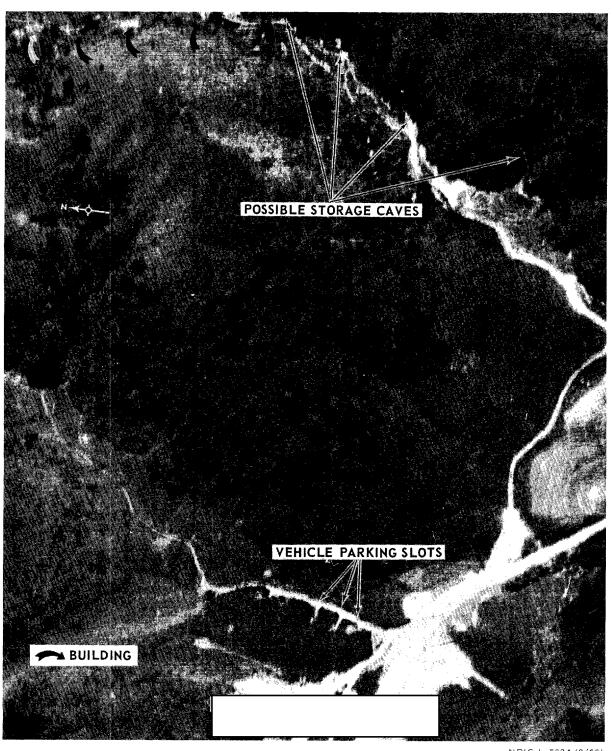
FIGURE 9. PROBABLE STORAGE AREA, ROUTE 6, NORTH VIETNAM

- Figure 9. A probable storage area is located north of Route 6 at 22-11N 103-11E (UTM UK123552) and contains five possible storage caves and at least eight buildings dispersed along a service road.

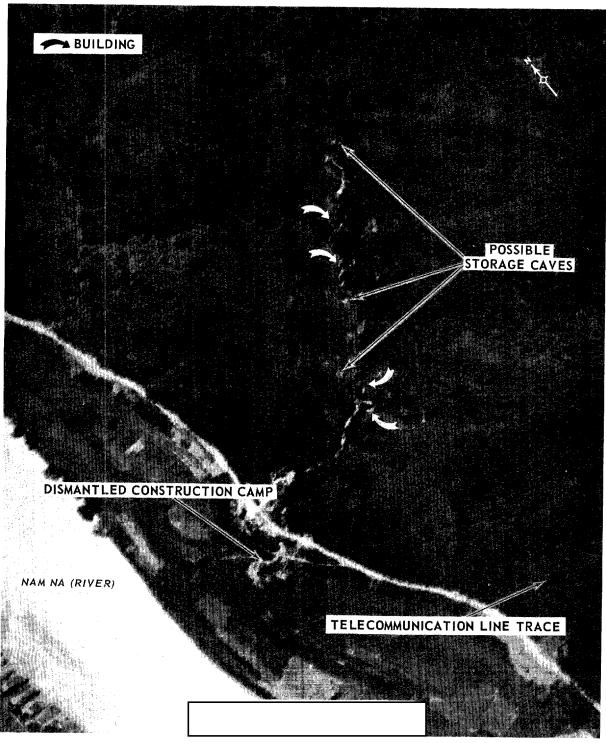
FIGURE 11. PROBABLE STORAGE AREA, ROUTE 6, NORTH VIETNAM

- Figure 11. A probable storage area is located northeast of Route 6 at 22-10N 103-12E (UTM UK132517) and contains three possible storage caves and at least four buildings dispersed along a service road. The site of a dismantled construction camp is located west of Route 6, opposite the entrance to the storage area.

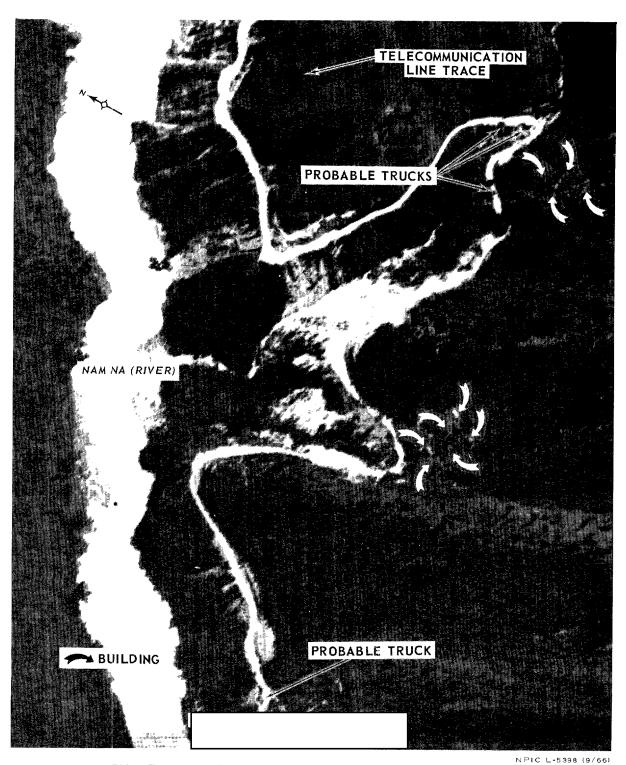
FIGURE 13. PROBABLE STORAGE AREAS, ROUTE 6, NORTH VIETNAM

- Figure 13. Two adjacent probable storage areas containing a total of

10 buildings are located south of Route 6 at 22-07N 103-12E (UTM UK137472).

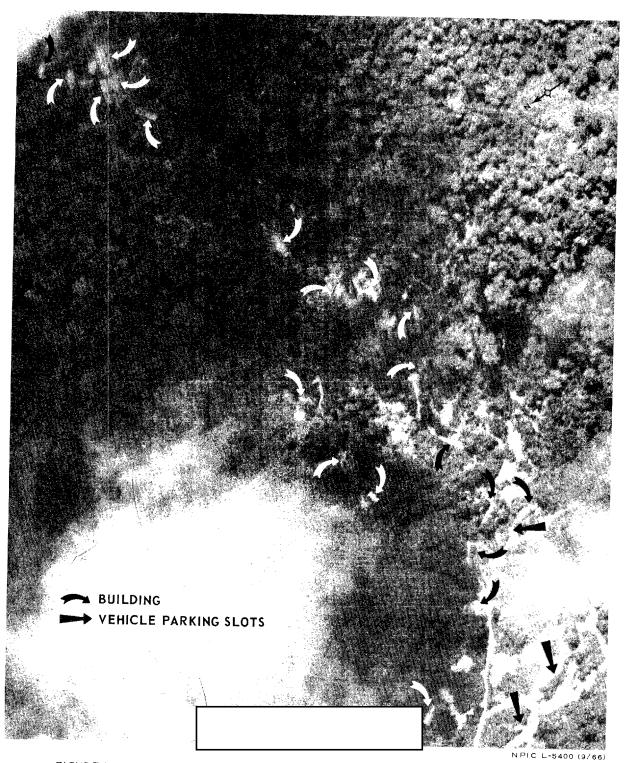
FIGURE 15. TRUCK PARK AND PROBABLE STORAGE AREA, ROUTE 4, NORTH VIETNAM

Figure 15. A probable storage area and truck park adjacent to Route 4 at 21-58N 103-09E (UTM UK096298) contains 20 buildings and at least three vehicle parking slots dispersed along a service road.

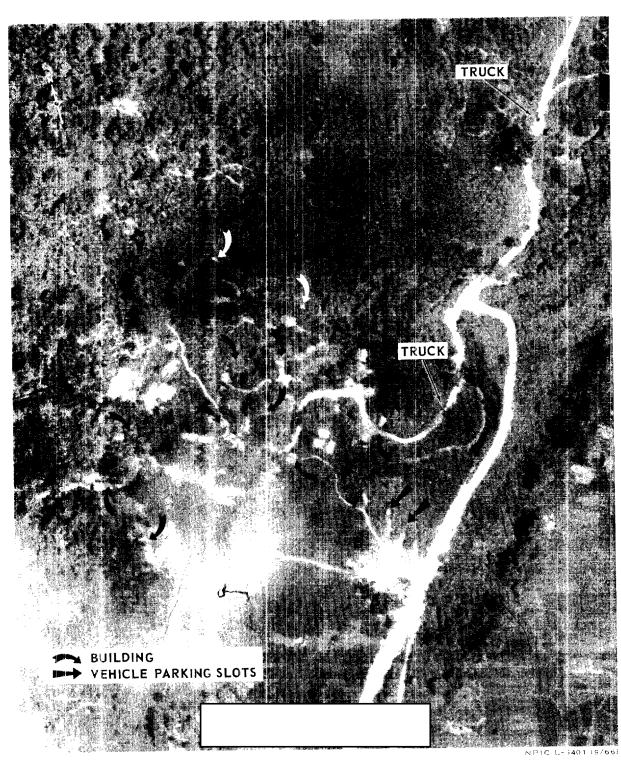
FIGURE 16. PR. BABLE STORAGE AREA, KOUTE 191, NORTH VIETNAM

Figure 16. A probable storage area adjacent to Route 191 at 21-56N 103-08E (UTM UKO82274) contains at least 11 buildings dispersed along two service roads. At least two vehicle parking slots are located along one service road and two trucks are in the area.

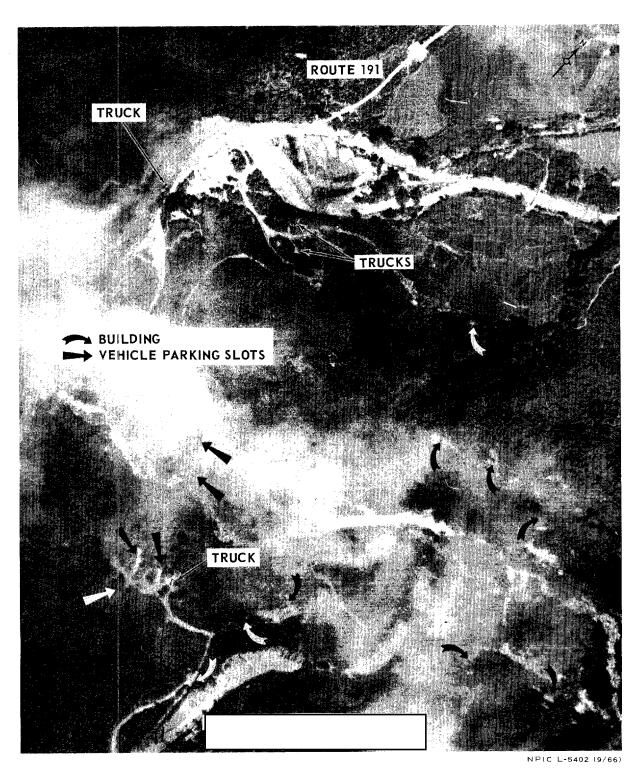
FIGURE 17. TRUCK PARK AND PROBABLE STORAGE AREA, ROUTE 191, NORTH VIETNAM

Figure 17. A truck park containing at least seven vehicle parking slots (partially cloud covered in photo) is adjacent to Route 191 at 21-56N 103-08E (UTM UK085267). Three trucks are observed in parking slots and one is fording a stream to the west. Several service roads connect nine dispersed buildings to Route 191.

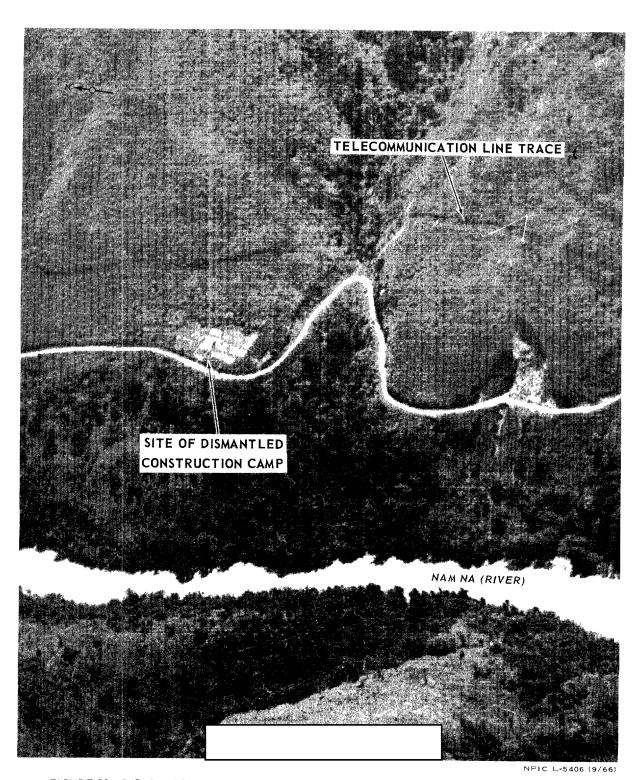
FIGURE 21. DISMANTLED CONSTRUCTION CAMP (22-22N 103-11E) ROUTE 6, NORTH VIETNAM

A major transition from road construction camps to dispersed, concealed storage facilities has been observed in the Lai Chau area of North Vietnam. Twenty facilities, predominantly storage, have been identified on Route 6 between Lai Chau and the China border and south of Lai Chau on Routes 4, 6, and 191 (Figures 1 - 20). An estimated total of 500 buildings have been dismantled in 15 road construction camps from 22-05N 103-10E to 22-28N 103-12E (e.g. Figures 21, 22, and 25) and in large residential and storage areas in Lai Chau (Figure 23).

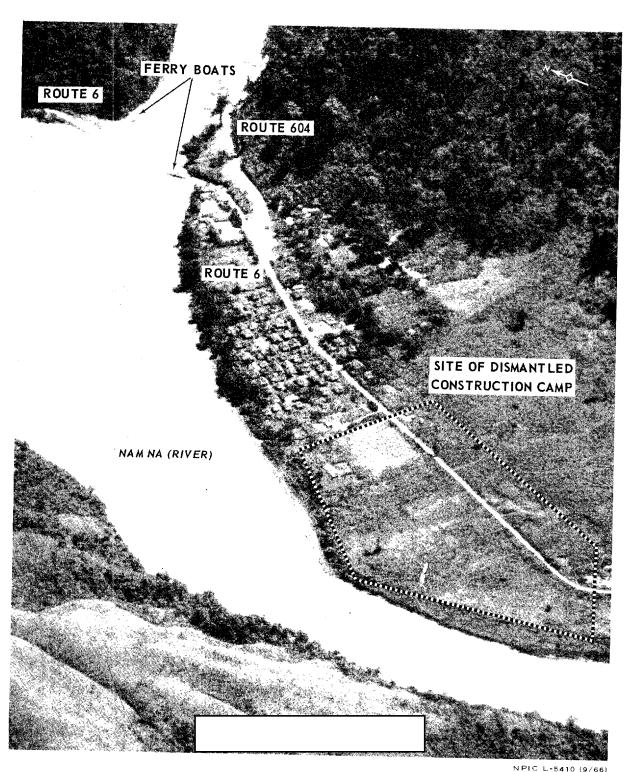
FIGURE 25. FERRY CROSSING AND DISMANTLED CONSTRUCTION CAMP (22-28N 103-12E), ROUTE 6, NORTH VIETNAM

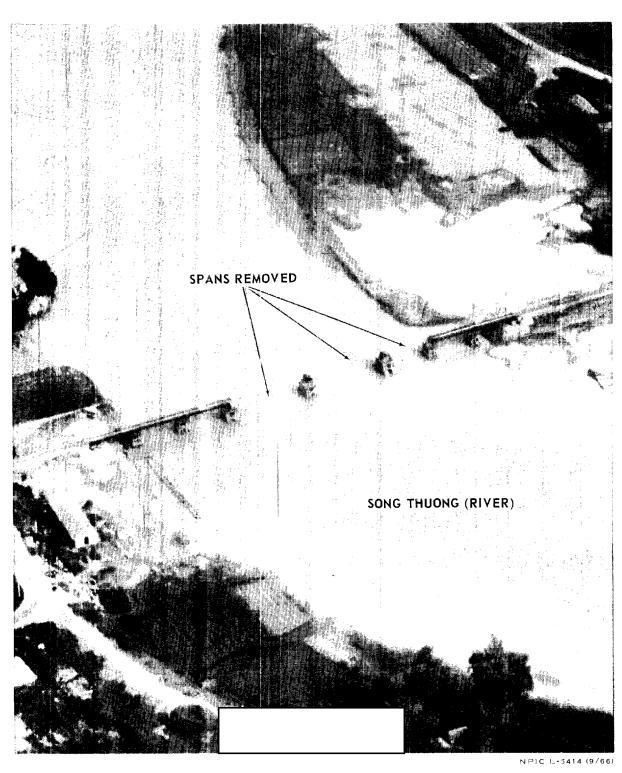
The three center spans have been removed at the Bac Giang railroad bypass bridge at 21-15N 106-17E (UTM XJ248518) on the Ha Noi/Ping-hsiang Rail Line (Figure 27). The bridge was apparently complete on ______ with all eight spans in place. Two probable half-through truss bridge sections are observed at UTM XJ228526, 700 yards west of the serviceable Bac Giang Railroad Bridge over the Song Thuong ______ Similar bridge sections were previously observed in the Bac Giang Railroad Yard at UTM XJ242532 (Figure 28). The by-pass bridge will probably remain in this dormant state until there is a change in the serviceability of the main bridge. It is not only effective deception, but renders the bridge less vulnerable in the event of air strikes in the area. This procedure was followed at Cao Nung, where the spans of the by-pass bridge were removed when the main bridge was completely reconstructed, and then replaced when the main bridge was again damaged.

FIGURE 27. BAC GIANG RAILROAD BY-PASS BRIDGE, HA NOI/PING-HSIANG RAIL LINE, NORTH VIETNAM

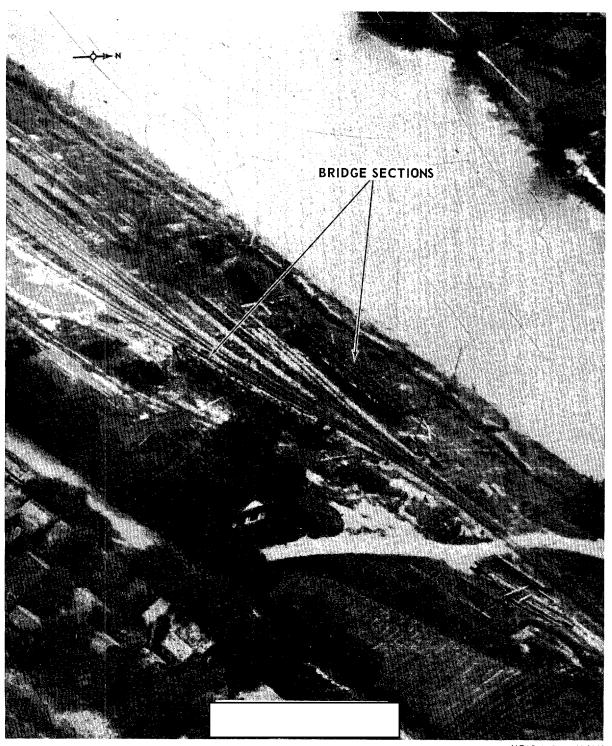
FIGURE 28. PROBABLE HALF-THROUGH TRUSS BRIDGE SECTIONS, BAC GIANG RAIL YARD, NORTH VIETNAM

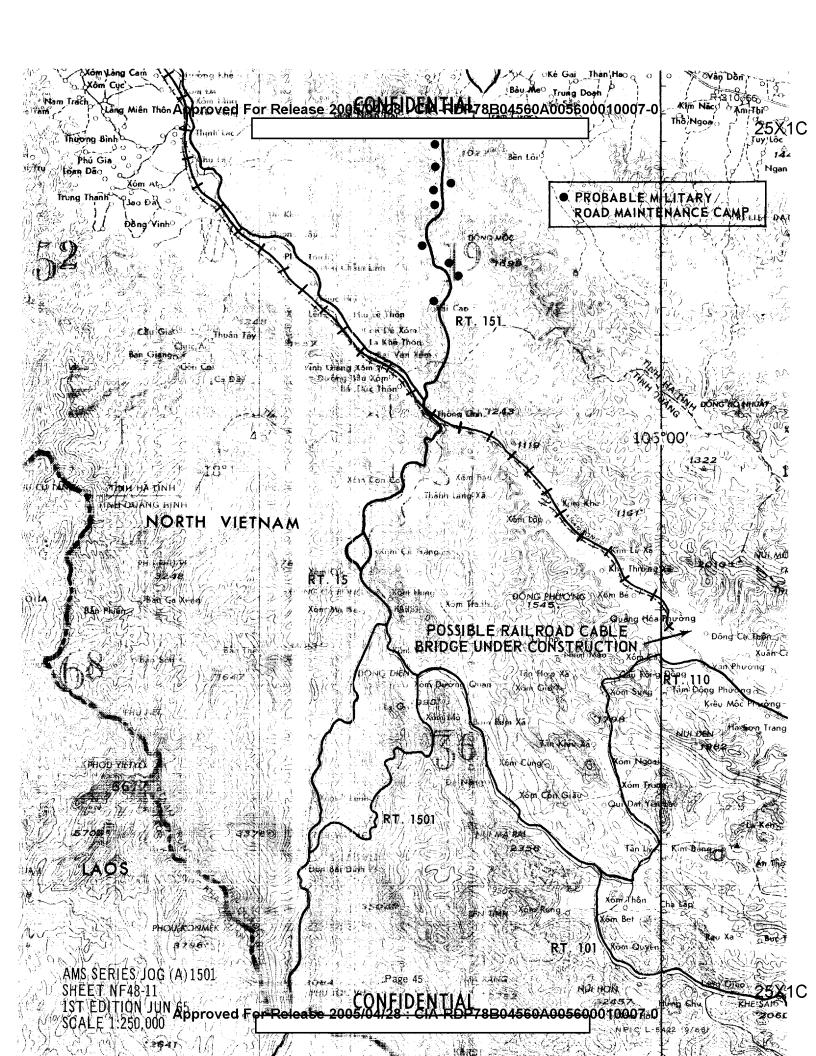
A possible railroad cable bridge is under construction on the Vinh/Dong Hoi Rail Line 0.7 nm southeast of the destroyed Thuong Phong Tran Railroad Bridge over the Rao Nay at 17-54N 106-00E (UTM XE075798). The approaches are in the initial stage of construction, extending from the river banks rather than from the main line. T-shaped cable anchorages are on both river banks and at least one taut cable is in place, indicating either a construction tramway or the initial construction of a railroad cable bridge. A railroad cable bridge is in the late stage of construction 0.6 nm west on the Vinh/Dong Hoi Rail Line.
